CASE STUDY

A lesson well learned

Project: Layfield Primary School

Membrane: SIGNature Bituminous Membrane

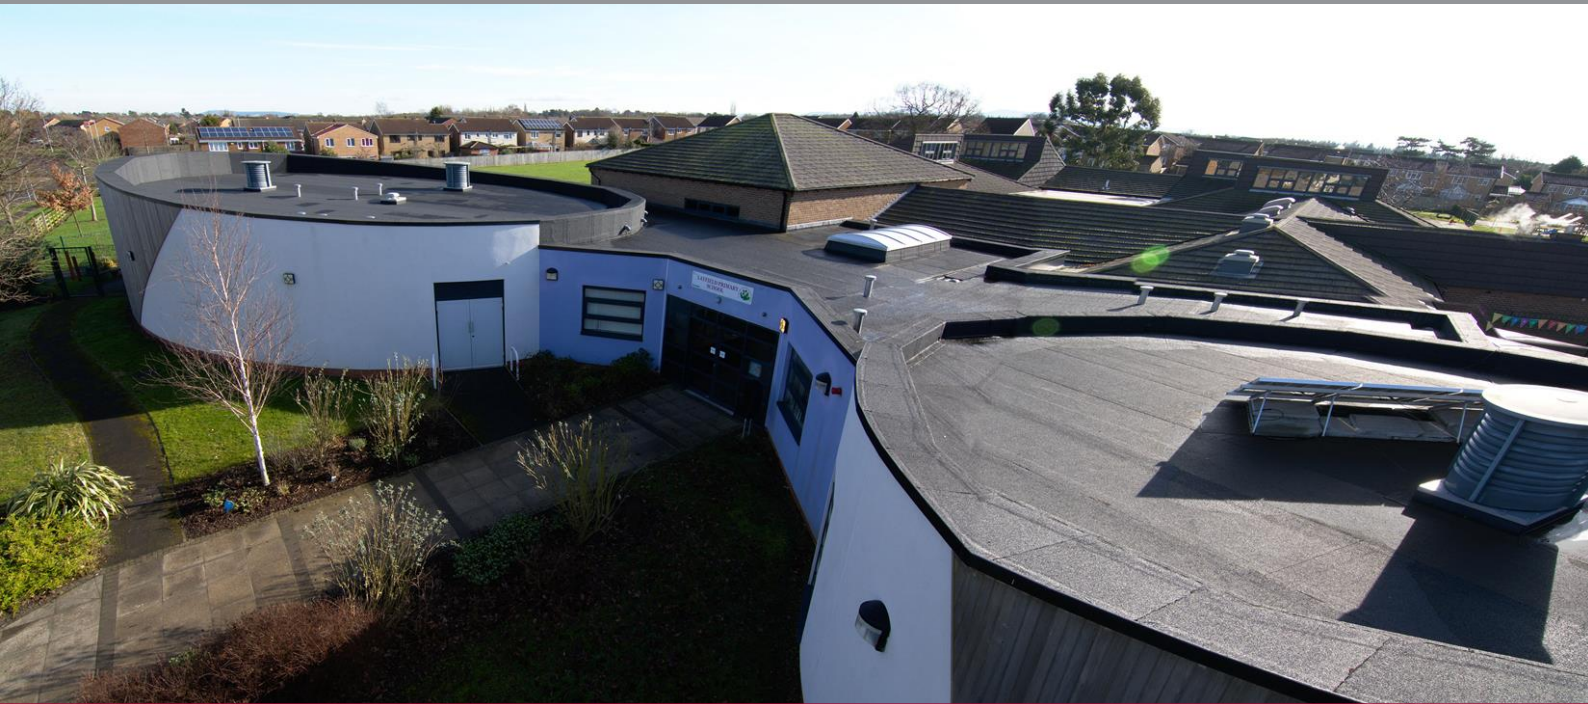
The new overlaid roof at Layfield Primary

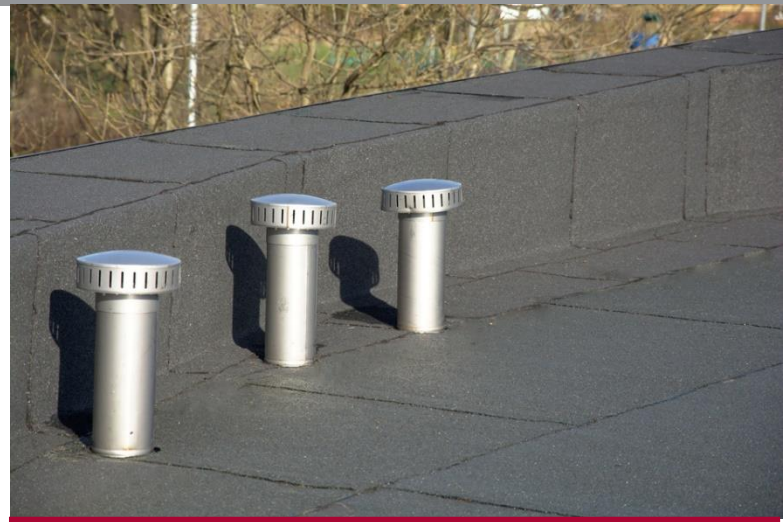
The leaking roof area consisted of two pitched oval roofs with a flat roof below. SIG's investigation identified the cause of the problem as the oval roofs, where inadequate detailing around the perimeter upstands and at the intersection with the lower roof had allowed water to ingress and find its way through to beneath the flat roof and down the walls into the school.

A crucial phase of the work was the correct detailing of the junctions with the flat roof.

The second, crucial phase of the work was the correct detailing of the junctions with the flat roof and the upstands around the roof perimeter. Roofix Ltd found a way to close mitre cut and bend the GRP trim insitu to fully encapsulate the upstand as an alternative to the original failed metal capping.

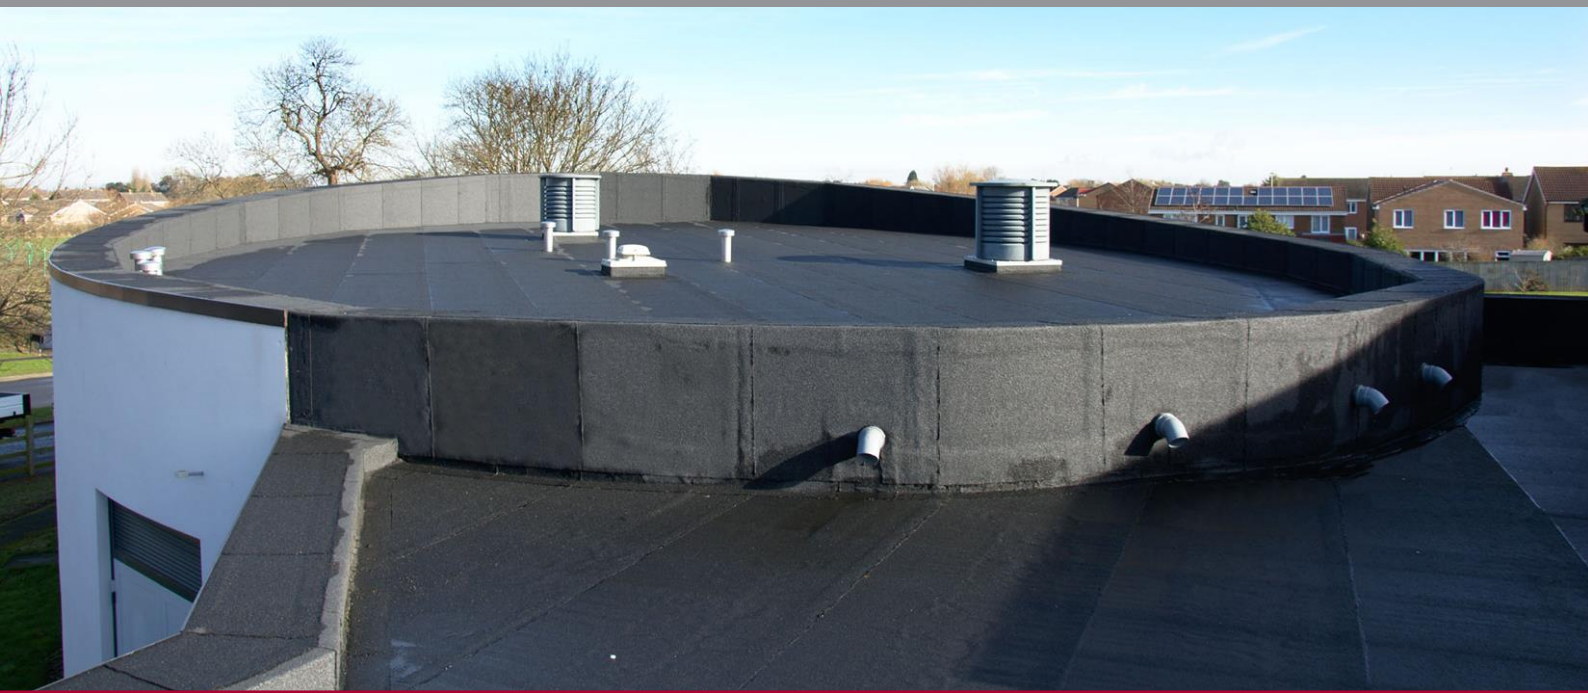
By avoiding complete stripping of the failed roofs, this strategy provided significant cost savings.

However SIG managed to find an economical solution for the 250sq m pitched oval roofs, which enabled the contractor to leave the original single ply roof in situ beneath the overlay rather than stripping and disposing of it, saving an estimated £60+ per metre.

SIG worked with contractor Roofix Ltd to install the SIGnature system as an overlay. To address the issue of potential plasticizer migration between the old and new roofs, a 300g separation fleece was fitted on the original roof followed by a mechanically fixed SIGnature25 underlay and a fully-torch bonded layer of underlay and cap sheet.
